NASA Technical Paper 1081

**Mechanical Behavior
and Fracture Characteristics
of Off-Axis Fiber Composites
I - Experimental Investigation**

John H. Sinclair and Christos C. Chamis

DECEMBER 1977

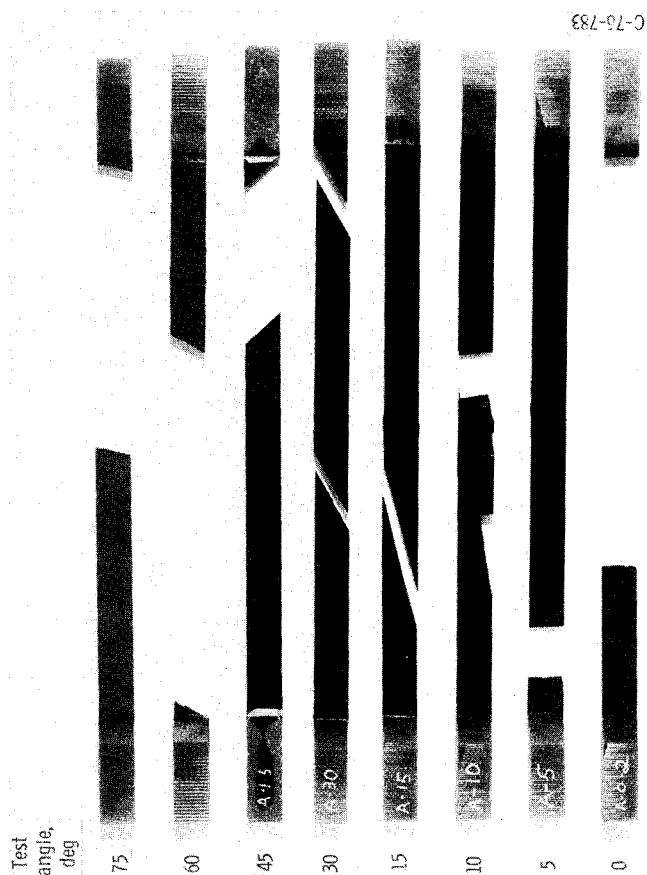
Figure 14. - Fractured test specimens (Mod I/E).

The fractured specimens are shown in figure 14. The fracture of a five-gage instrumented specimen is shown in figure 15. Note in figure 14 that the specimens tested at 0° , 5° , 10° , 15° , and 30° off-axis fractured away from the end tabs and those tested at 45° , 60° , 75° and 90° fractured near the end tab. Fractures occurring at or near end tabs are to be expected. Finite-element analyses results to be discussed in Part II show that the stresses at the edge near the end tab are higher than at the center in certain orientations. Consequently, these stresses can initiate fractures near the end-tab region. This leads to the interpretations that the fracture stresses of specimens that fractured near the end tabs are on the conservative side. Therefore, the axial stress

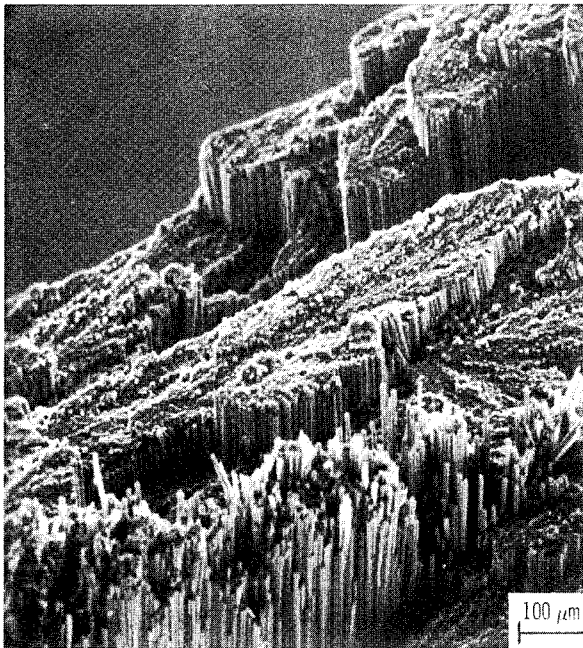
(a) General view.

(b) Detailed view.

(c) Enlargement of detail to show fracture mode.

Figure 16. - Scanning electron photomicrographs of fractured surface of Mod I/E composite tested parallel to fiber direction.

The fracture surface of the 0° specimen is shown in figure 16(a), where it can be observed that the fracture surface is irregular. An area replete with pulled-out fibers that broke off at varying lengths can be observed in the left foreground of the figure. This type of fracture suggests poor bonding between matrix and fibers. The remaining areas of figure 16(a) show irregularly shaped tiered or stepped surfaces that are typical of most of the fracture surface of specimens tested in longitudinal tension. At some regions fibers over relatively large areas fractured at approximately the same level, and they show little fiber pull-out. This type of surface is enlarged in figures 16(b) and (c). There was strong bonding between the fibers and matrix in these areas. The fracture mode of the resin was cleavage (fig. 16(c)). Lateral fiber surfaces of these stepped zones show some evidence of sheared resin lying between the fibers as seen in the upper left of figure 16(c).

The fracture surface in figure 16(c) reveals several distinct features. These features and some significant implications following therefrom are as follows:

- (1) The fiber fracture surface is irregular but appears to be symmetric from the perimeter towards the center. This type of fiber fracture surface morphology will be considered to be typical of tensile fracture.
- (2) The matrix fracture surface between fibers at the same level is smooth, indicating tensile brittle fracture by cleavage.
- (3) The matrix fracture surface between fibers at different levels is lacerated, indicating fracture by tear, which will be considered to be fracture by intralaminar shear.
- (4) The surface of fibers that pulled out appears to be clear of matrix residue, in general. This indicates weak interfacial bonding which may be construed to imply that the interfacial bond is predominantly mechanical.
- (5) The transverse split in the left foreground is probably caused by the elastic energy release after fracture backlash.

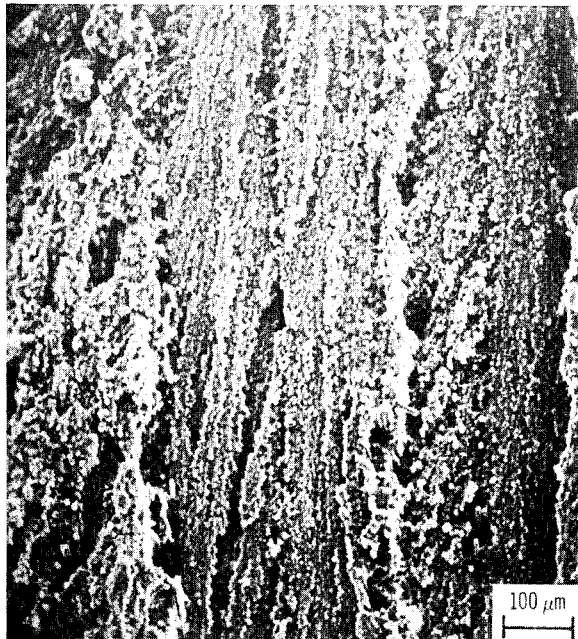
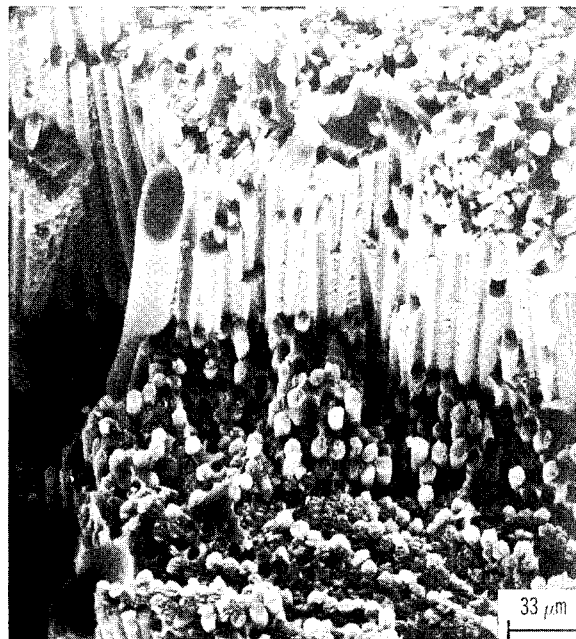
(a) General view.

(b) Detailed view.

(c) Enlargement of detail to show fracture mode.

Figure 17. - Scanning electron photomicrographs of fractured surface of Mod I/E composite tested at 5° to fiber direction.

The fracture surface of the 5° off-axis tensile specimen (fig. 17) reveals the following features:

- (1) Surface tiering (fig. 17(b)) and matrix cleavage (fig. 17(c)) both of which are indicative of tensile fracture
- (2) Extensive matrix surface lacerations, indicating substantial fracture by intralaminar shear
- (3) Fiber pull-out and fiber surfaces free of matrix residue, indicating weak interfacial bonding.

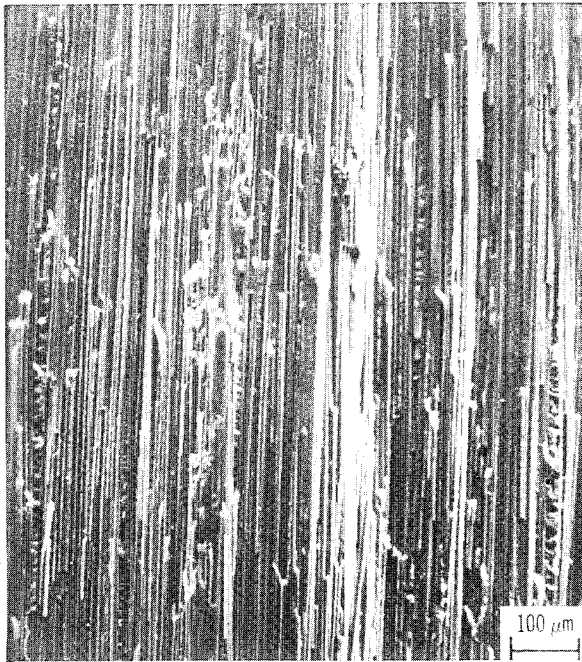
(a) General view.

(b) Detailed view.

(c) Enlargement of detail to show fracture mode.

Figure 19. - Scanning electron photomicrographs of fractured surface of Mod I/E composite tested at 15° to fiber direction.

The fracture surfaces of the 15° and 30° off-axis tensile specimens (figs. 19 and 20) reveal similar features to those of the 10° off-axis tensile specimen. These surfaces, too, indicate that fracture was induced mainly by intralaminar shear stress.

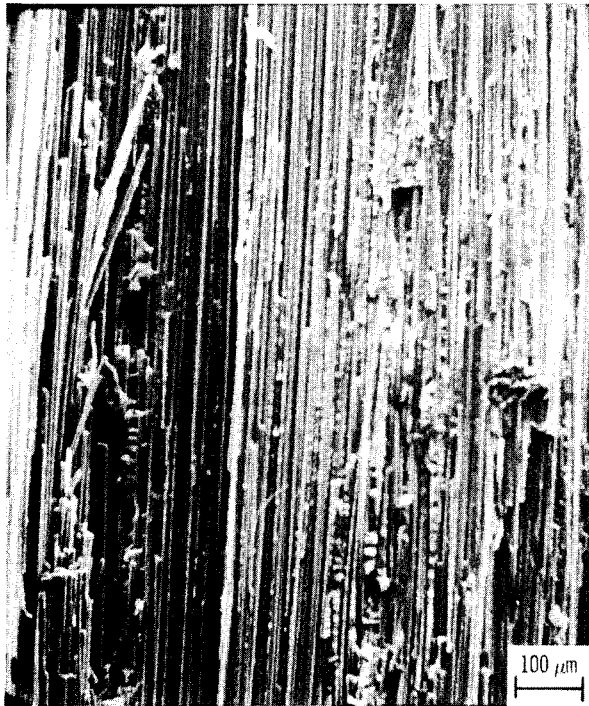
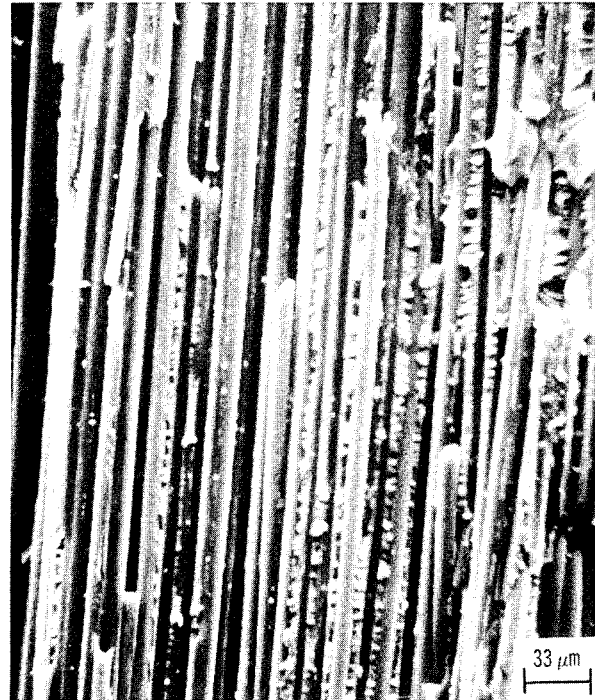
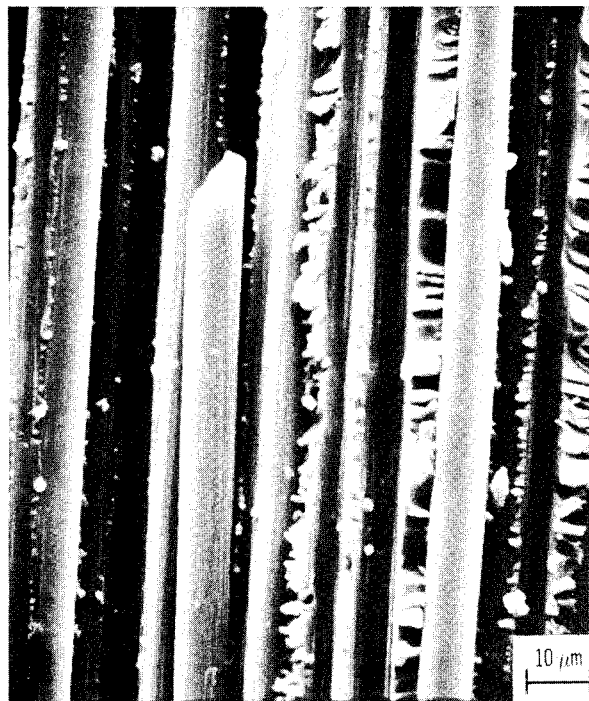
(a) General view.

(b) Detailed view.

(c) Enlargement of detail to show fracture mode.

Figure 20. - Scanning electron photomicrographs of fractured surface of Mod I/E composite tested at 30° to fiber direction.

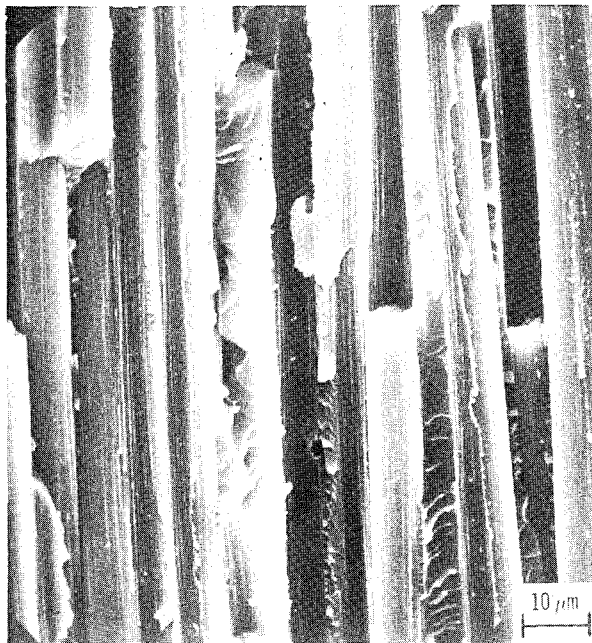
(a) General view.

(b) Detailed view.

(c) Enlargement of detail to show fracture mode.

Figure 22. - Scanning electron photomicrographs of fractured surface of Mod I/E composite tested at 60° to fiber direction.

The fracture surfaces of the 60° off-axis tensile specimen (fig. 22) and the 75° specimen (fig. 23) reveal mainly matrix cleavage and some fiber surface free of matrix residue; both of these features indicate that fracture was induced by transverse tensile stress.

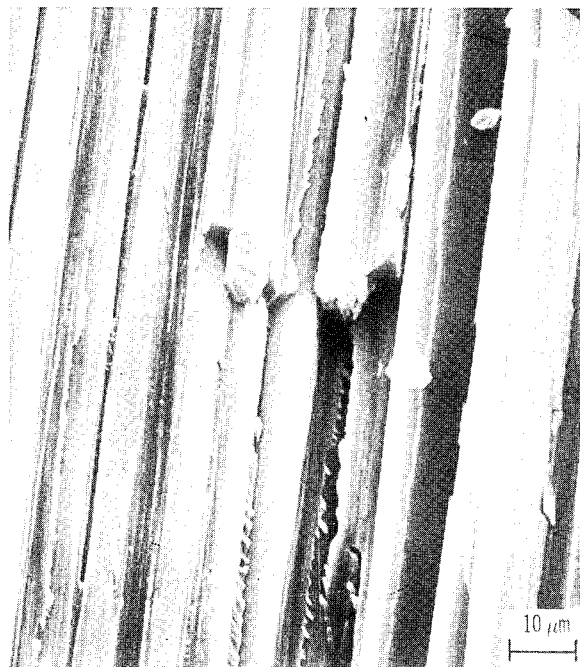
(a) General view.

(b) Detailed view.

(c) Enlargement of detail to show fracture mode.

Figure 23. - Scanning electron photomicrographs of fractured surface of Mod I/E composite tested at 75° to fiber direction.

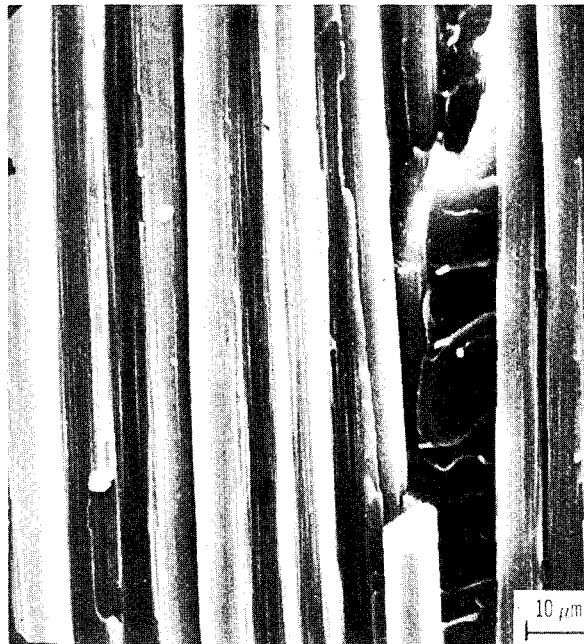
(a) General view.

(b) Detailed view.

(c) Enlargement of detail to show fracture mode.

Figure 24. - Scanning electron photomicrographs of fractured surface of Mod I/E composite tested transverse to fiber direction.

The fracture surface of the 90° tensile specimen (fig. 24) reveals the following features:

- (1) Matrix cleavage, indicative of tensile fracture of brittle materials
- (2) Fiber surfaces free of matrix residue, indicative of weak interfacial bond, as was already mentioned
- (3) Some matrix lacerations, indicating shear fracture at surfaces connecting two different levels.

These features indicate that transverse tensile stress produces fracture surfaces characterized by (1) matrix cleavage and (2) fiber surfaces clear of matrix residue.
